Rimkus Consulting Group, Inc.
Eight Greenway Plaza, Suite 500
Houston, TX 77046
(800) 580-3228 Telephone
(713) 623-4357 Facsimile

Re: RCG File No: 11009971
LLV Number: 0209452
VMF Location: 1530 Greensmark Drive in Houston, Texas
Subject: Final Report

Rimkus Consulting Group, Inc. was retained to examine LLV 0209452, VIN 1GBCS10E4M2908832. The fire occurred on June 13, 2016 at around 12:30 P.M. the operator of the vehicle at the time of the fire, was unavailable for interview but reportedly stated the vehicle's engine died while delivering mail on his route and backfired during subsequent attempts to restart it. Soon thereafter, smoke was observed from beneath the hood as well as flames.

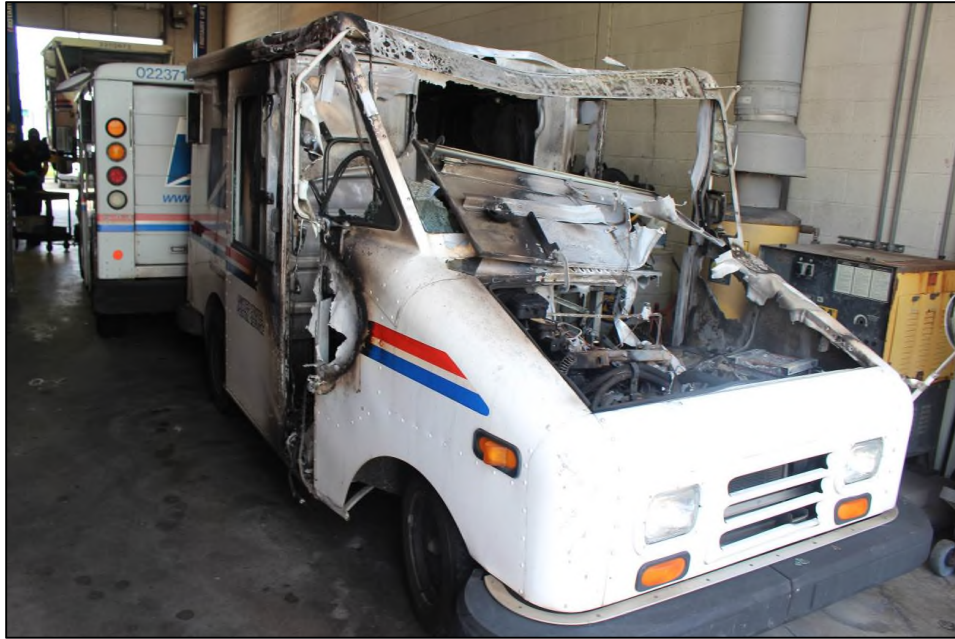
Photograph 1

View of fire-damaged vehicle from right front corner on driver side.

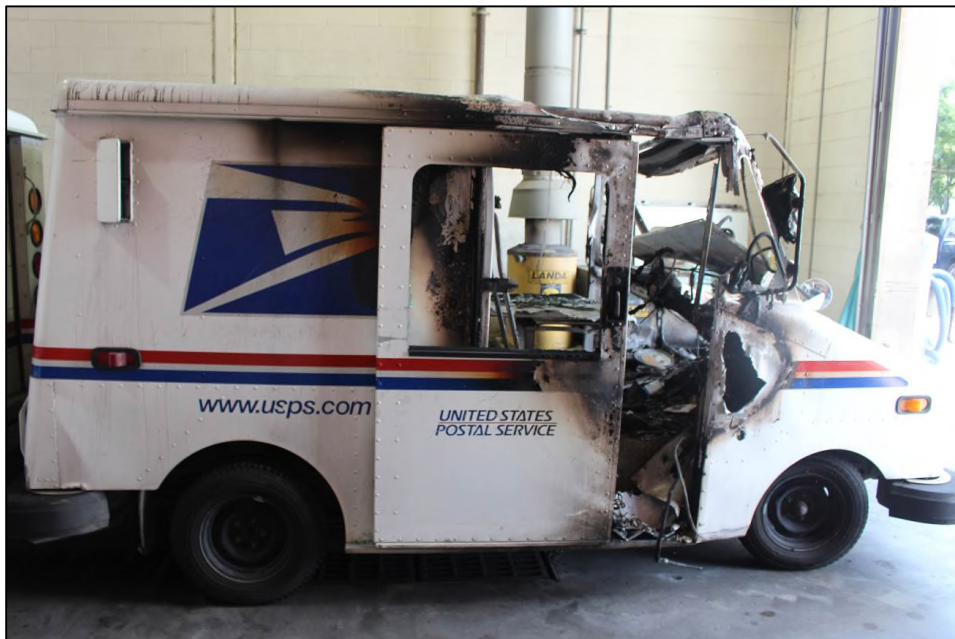
Photograph 2

View from right side.

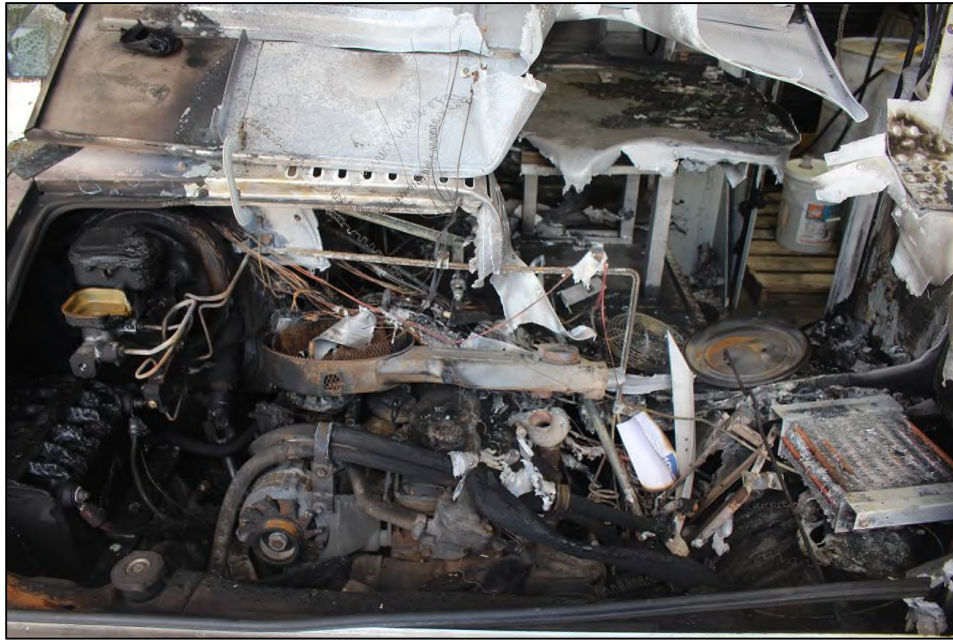
Photograph 3

View of engine compartment.

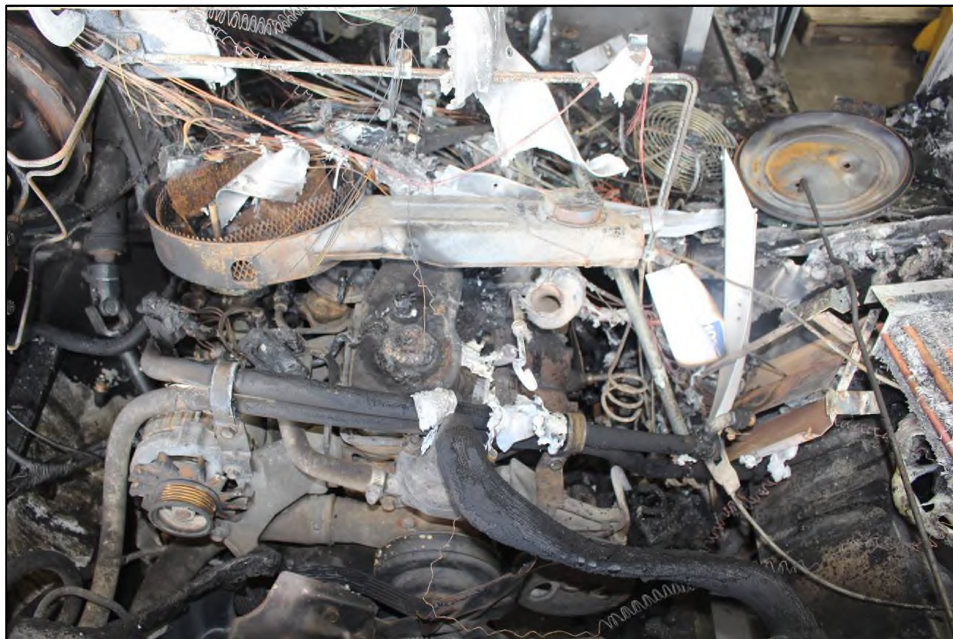
Photograph 4

Right driver side (i.e. at left) and front of engine compartment shows comparatively less fire damage than opposite side (i.e. on right.).

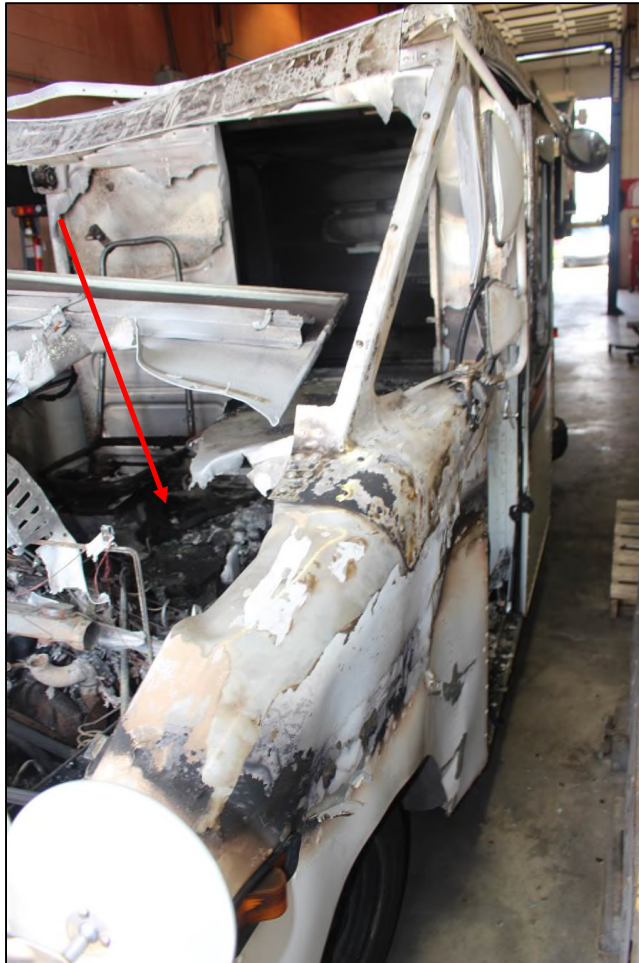
Photograph 5

1. The fire was determined to have originated in the engine compartment of the involved LLV.

Left side view from front. Arrow indicates left side of engine within the engine compartment where the fire originated.

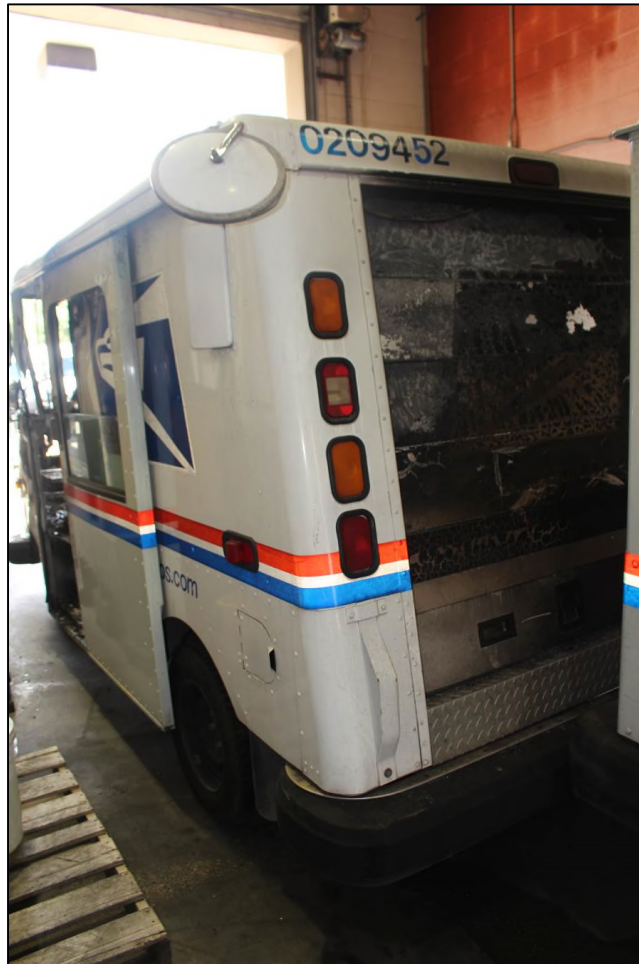
Photograph 6

Left side profile view from rear corner of cargo area.

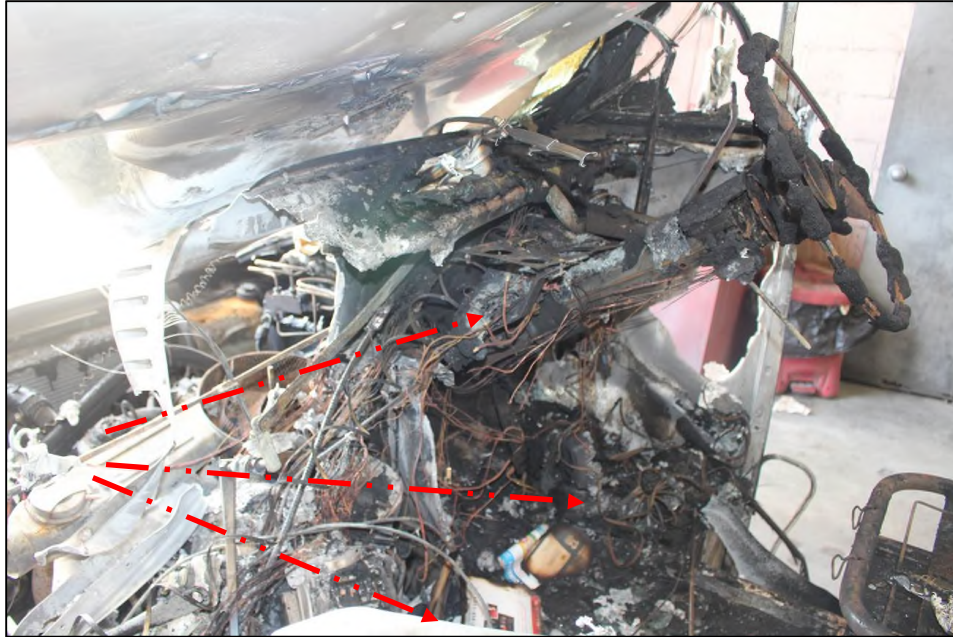
Photograph 7

View of interior of driver compartment showing breach of fire through firewall from engine compartment on left side into the compartment.

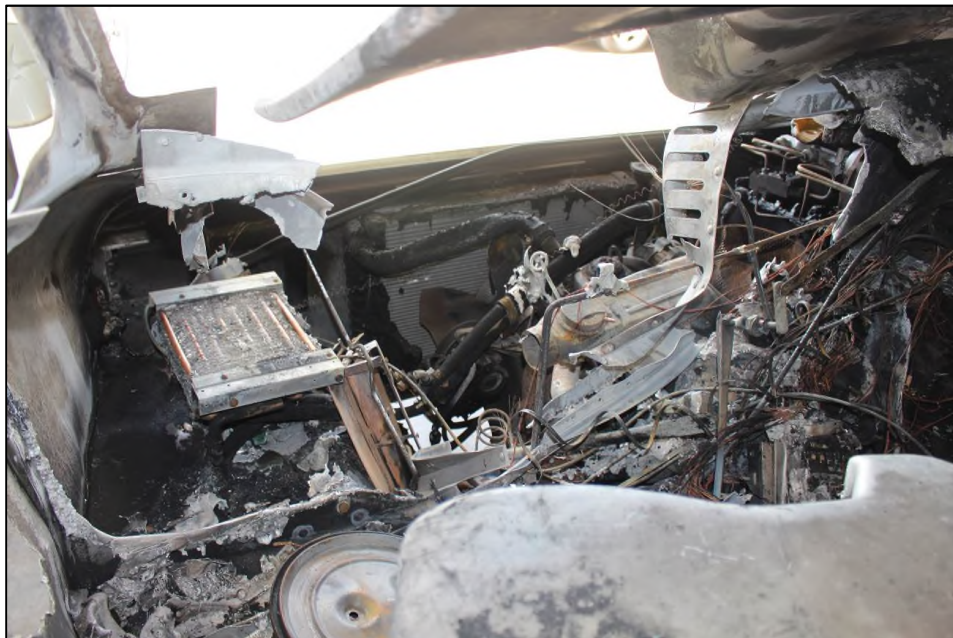
Photograph 8

View from interior of compartment through breach of consumed firewall through left side of engine compartment.

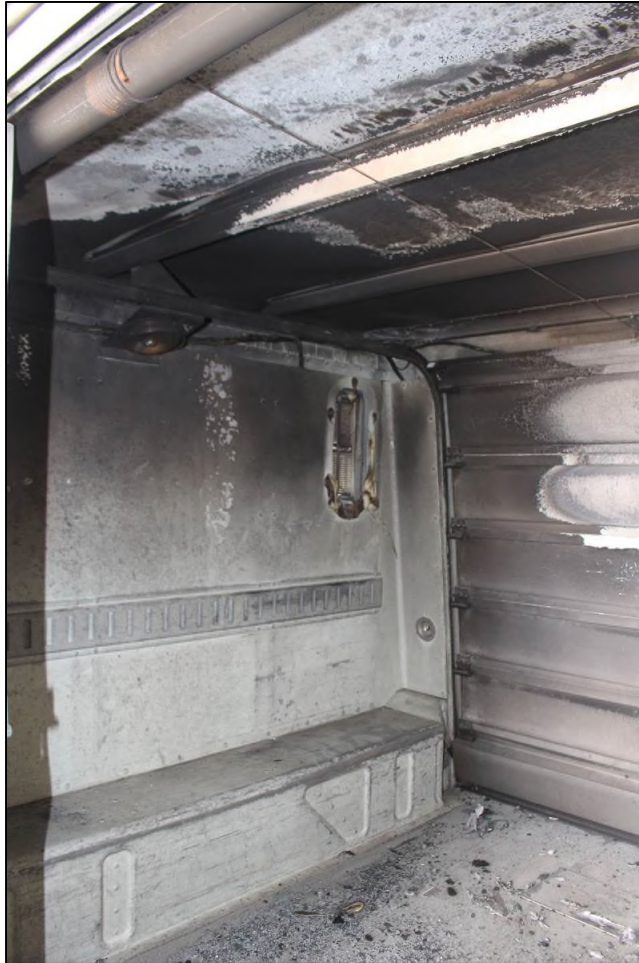
Photograph 9

View of interior of rear cargo area showing heat stress and smoke penetration into the compartment from the fire that originated inside the engine compartment before breaching through the firewall into the driver compartment.

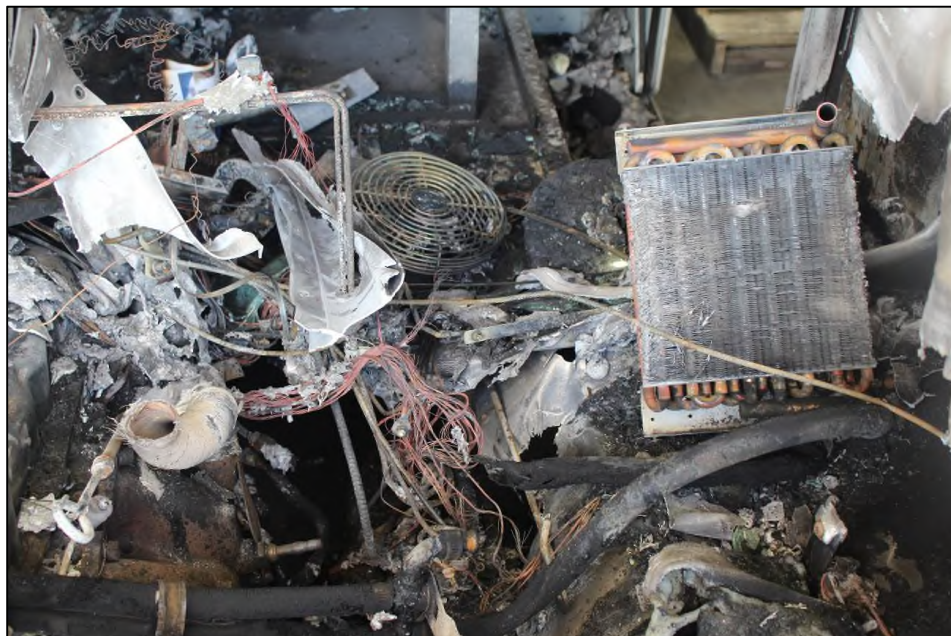
Photograph 11

Area of fire origin prior to removal of components and debris that were damaged by the fire and dislocated during subsequent of the vehicle to storage and prior to the examination.

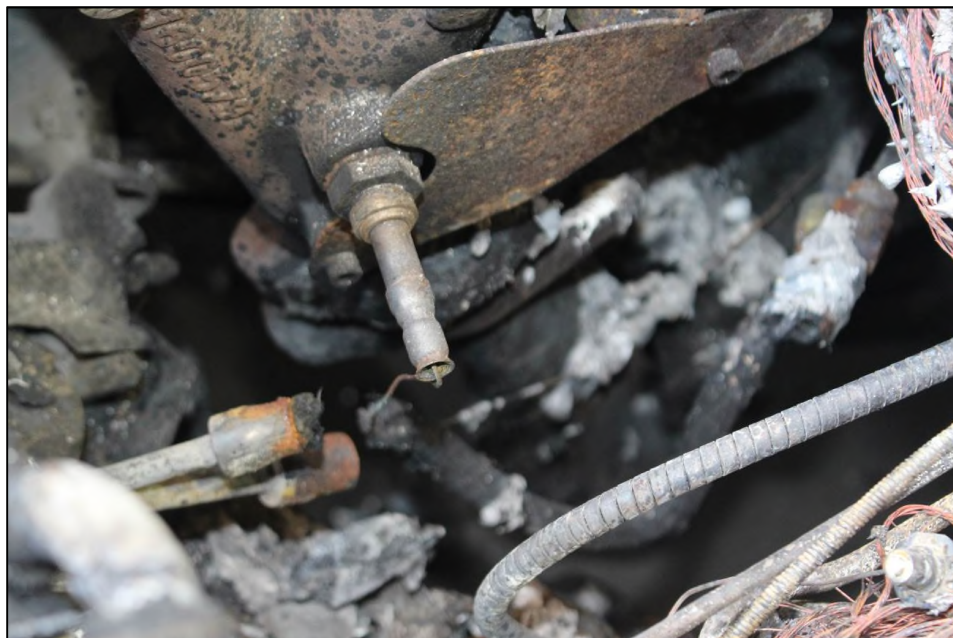
Photograph 13

Closer view of same area showing damaged fuel lines and area of missing fuel filter.

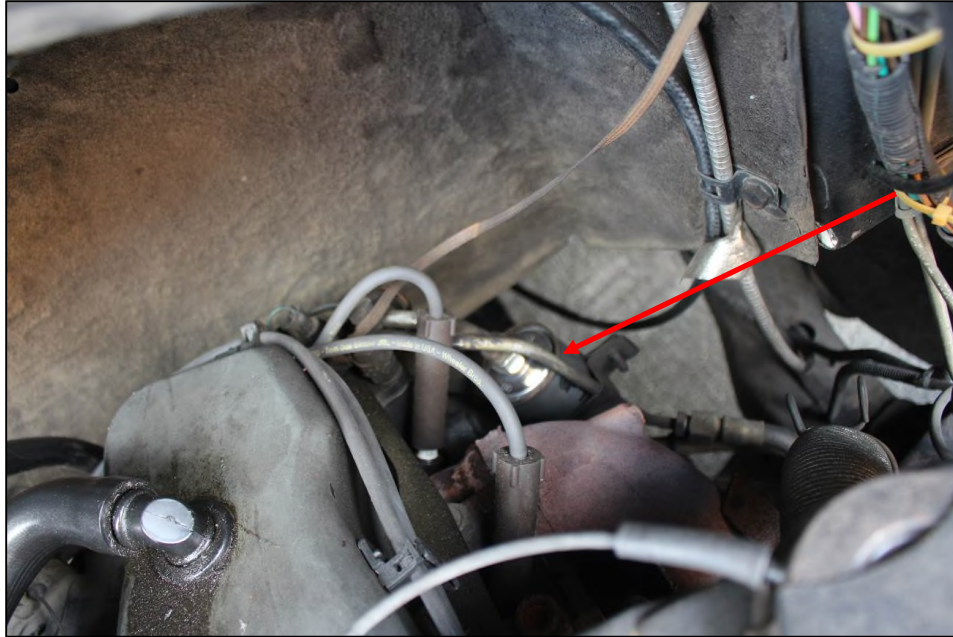
Photograph 14

Photo of exemplar vehicle similar to the damaged one that shows mounting location of installed fuel filter and connection to fuel lines.

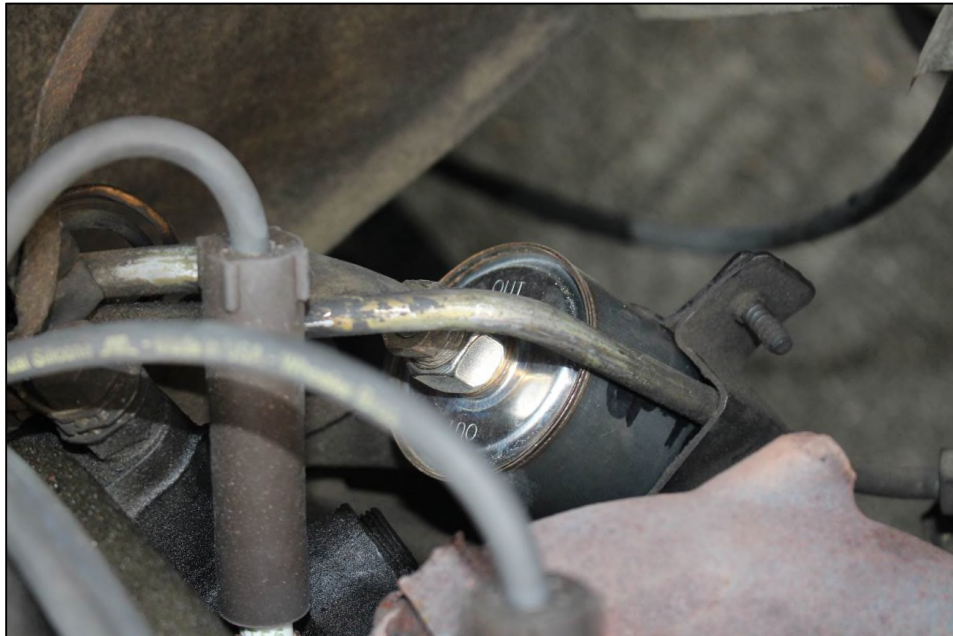
Photograph 15

Close-up of exemplar fuel filter installation on exemplar vehicle.

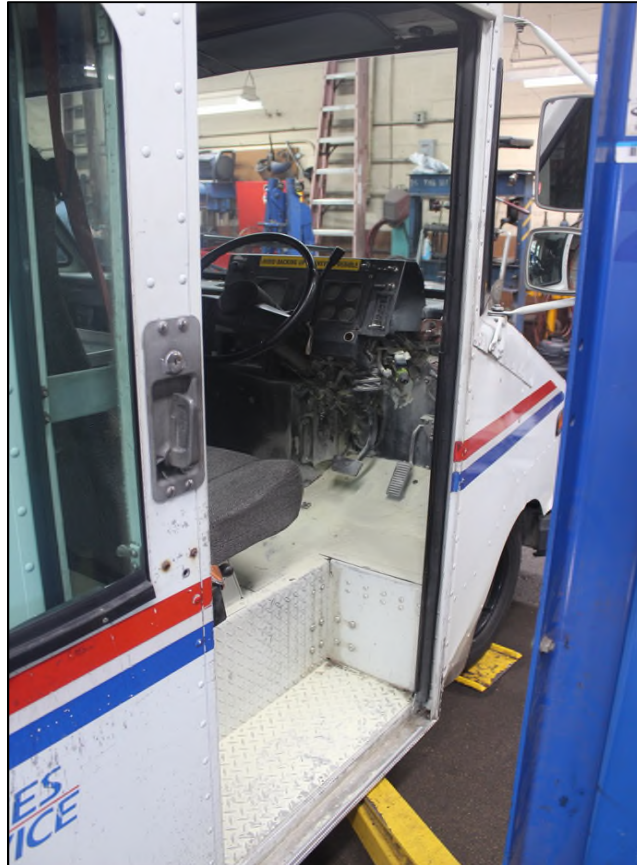
Photograph 1

Driver door right side with dry chemical agent on floor and steering column.

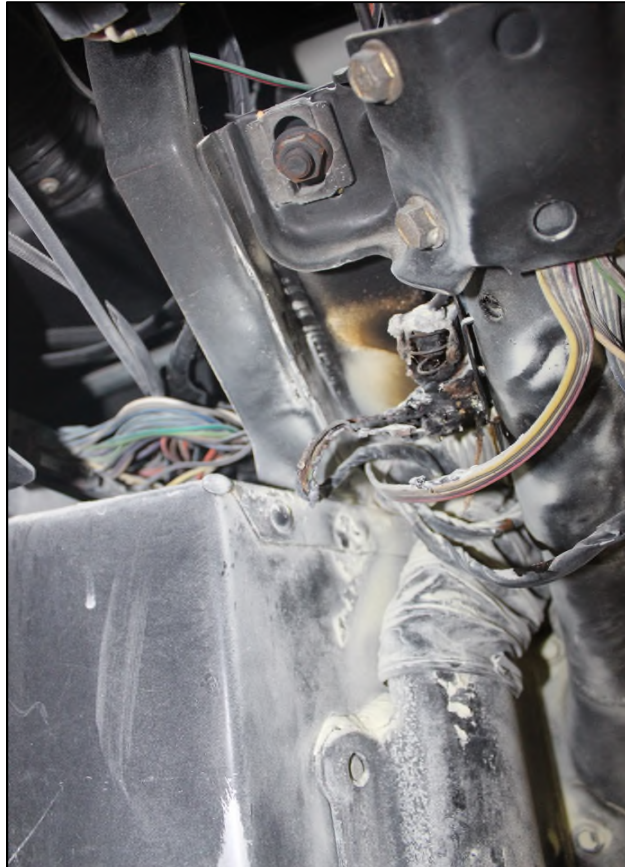
Photograph 2

Based on our observations it was our opinion the area of fire origin was in the driver compartment on the left side of the steering column at the headlight dimmer switch. Fire damage was limited to melting and some char to the plastic switch body and adjacent electrical circuits.

Fire damage limited to left side of steering column at headlight dimmer flasher switch.

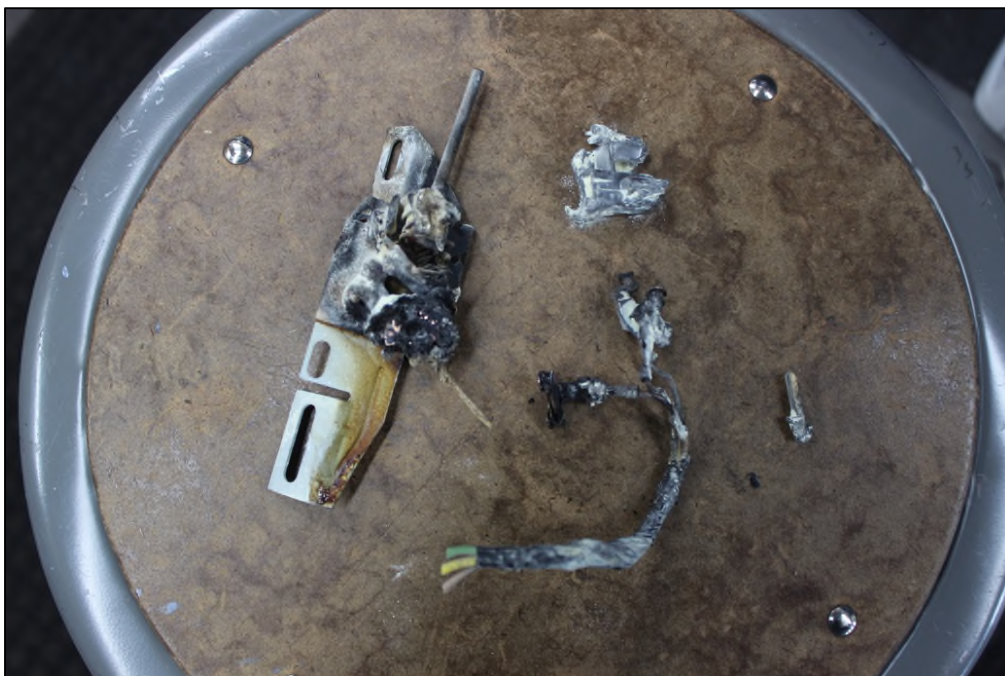
The LLV reportedly was being driven at the time of the fire. The headlamps were in the "on" position per policy. A failure of the rheostat switch caused it to heat and ignited surrounding combustible materials. Based on our examination, it is our opinion overheating of the rheostat switch was the source of the fire ignition.

Switch removed from vehicle with heat and fire damage to components.

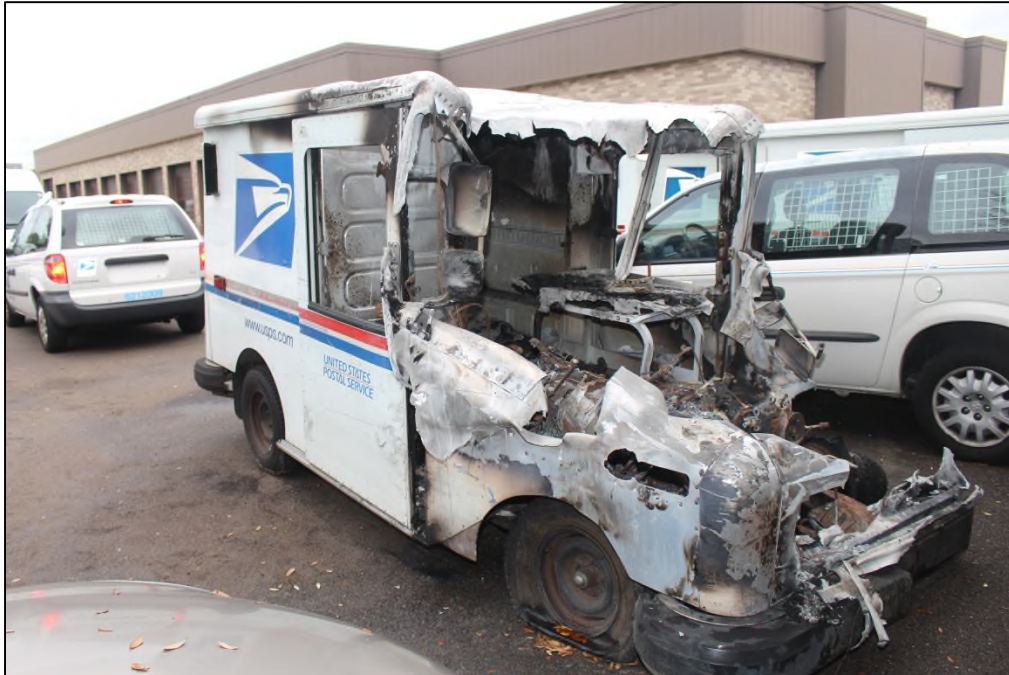
Photograph 1

A view of the front and driver side of LLV 4307708.

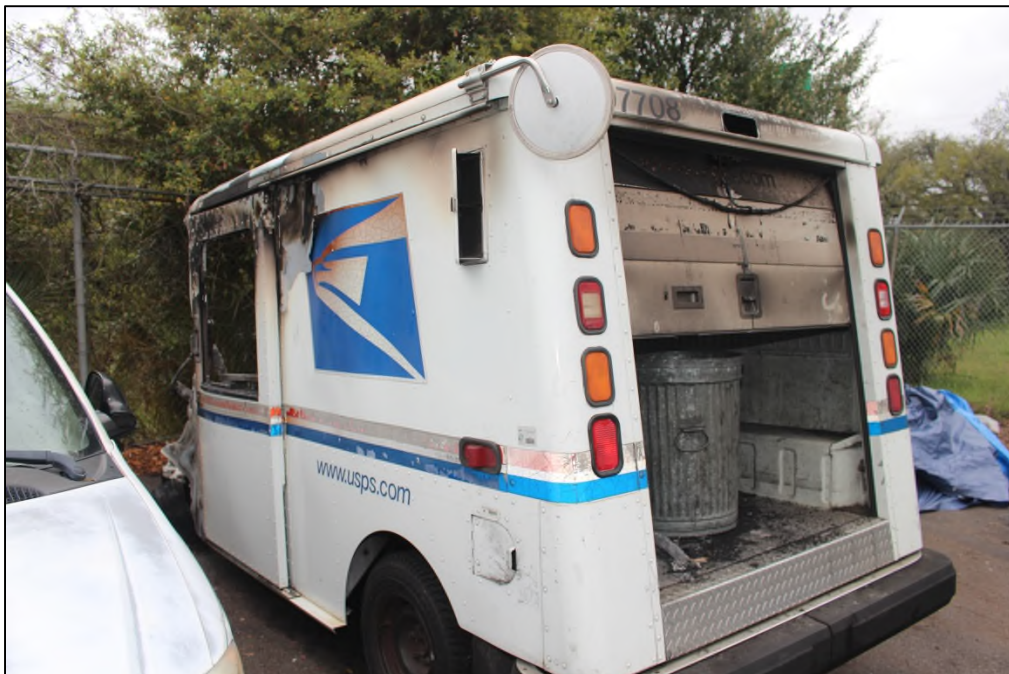
Photograph 2

A view of the rear and passenger side of LLV 4307708.

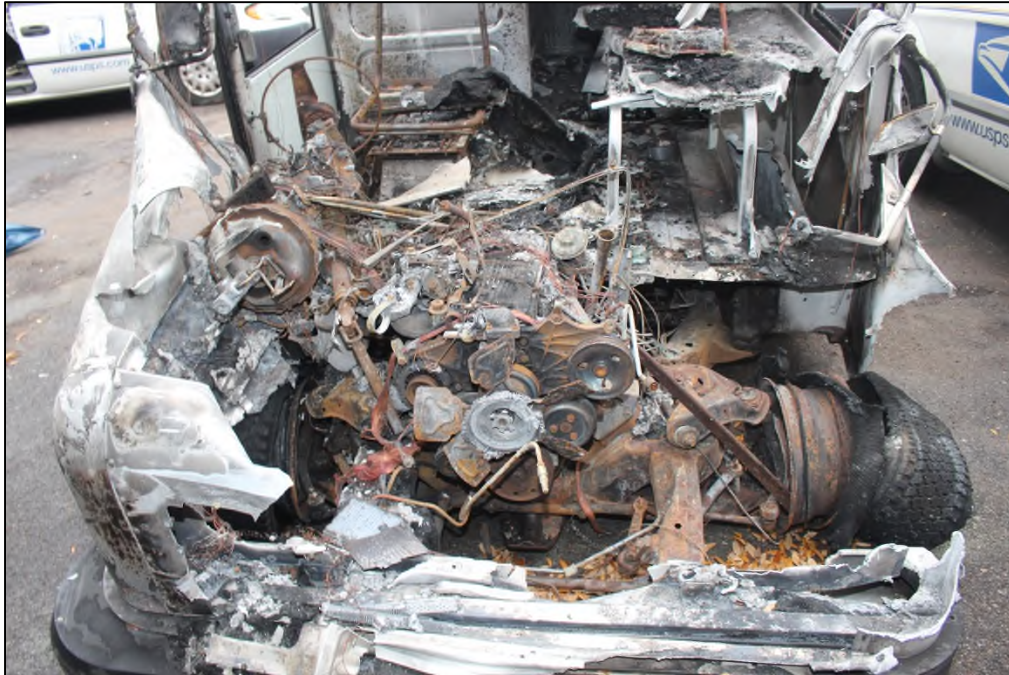
Photograph 3

A view of the severe damage to the engine compartment.

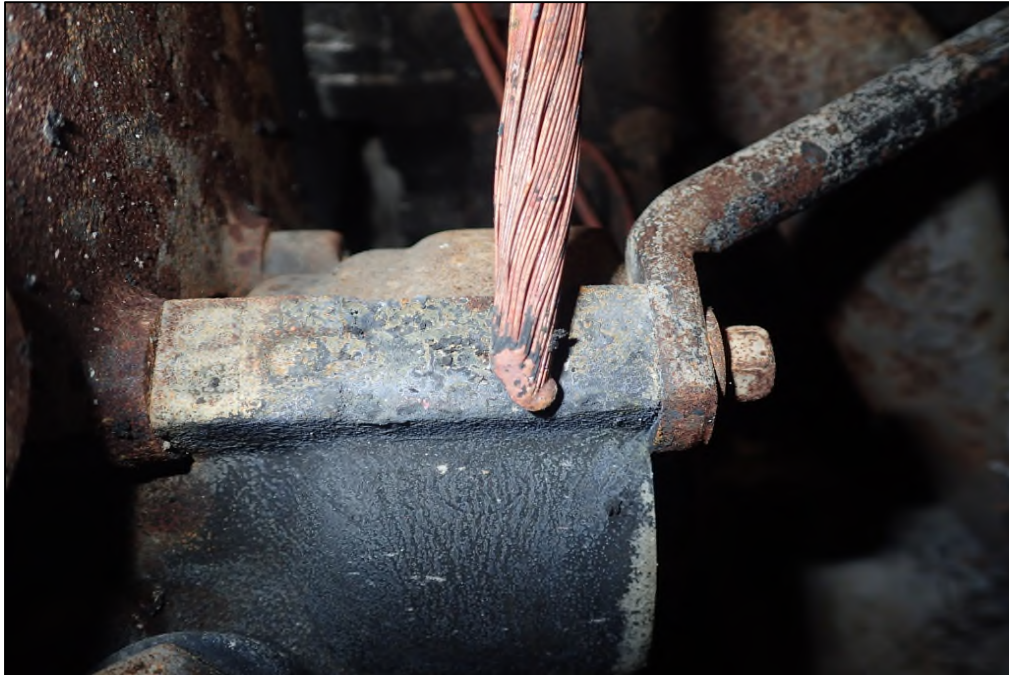
Photograph 5

A view of an arc bead to the upper portion of the battery cable.

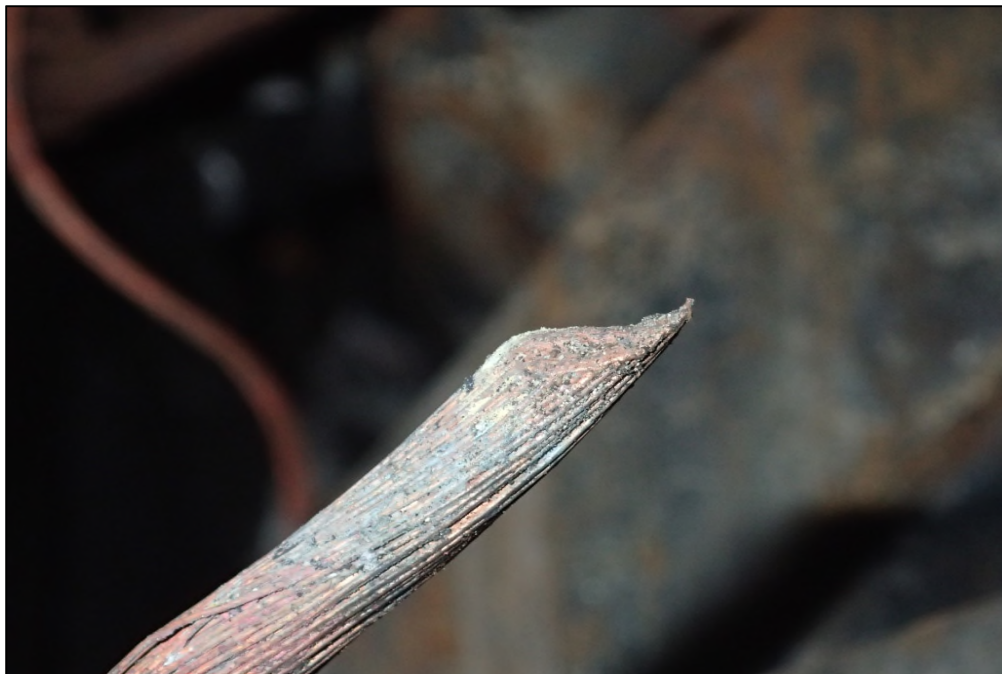
Photograph 6

A view of the arc damage to the lower portion of the battery cable.

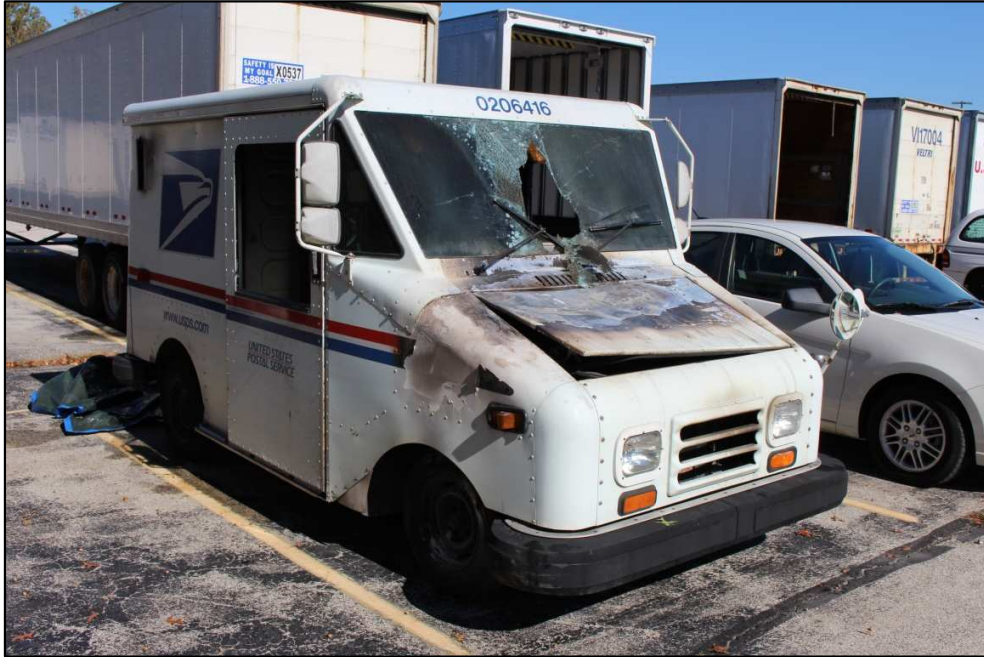
Photograph 1

Front right side view of vehicle.

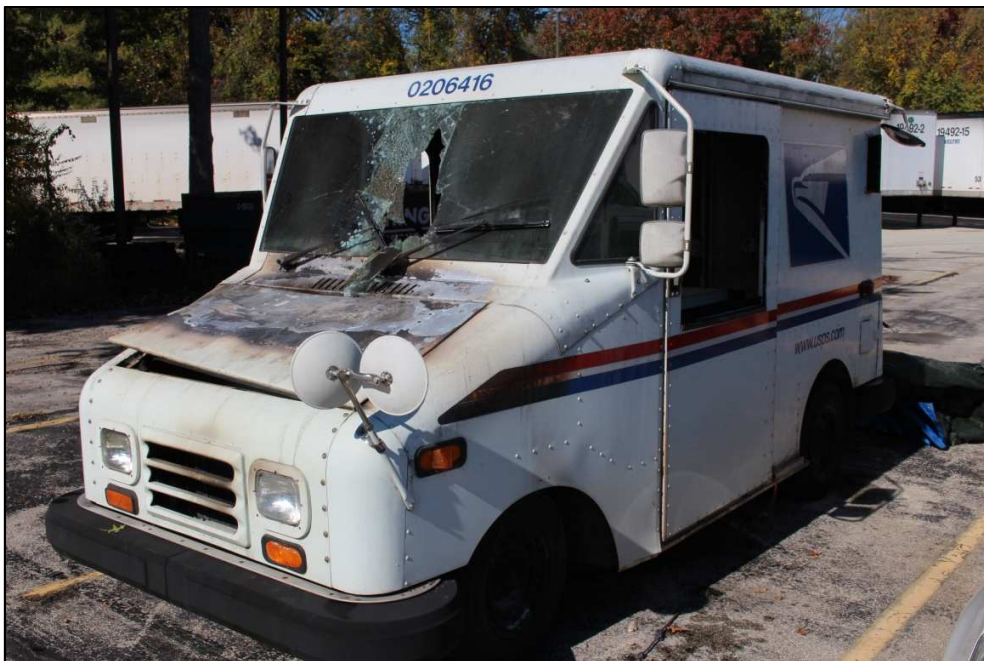
Photograph 2

Front left side view of vehicle.

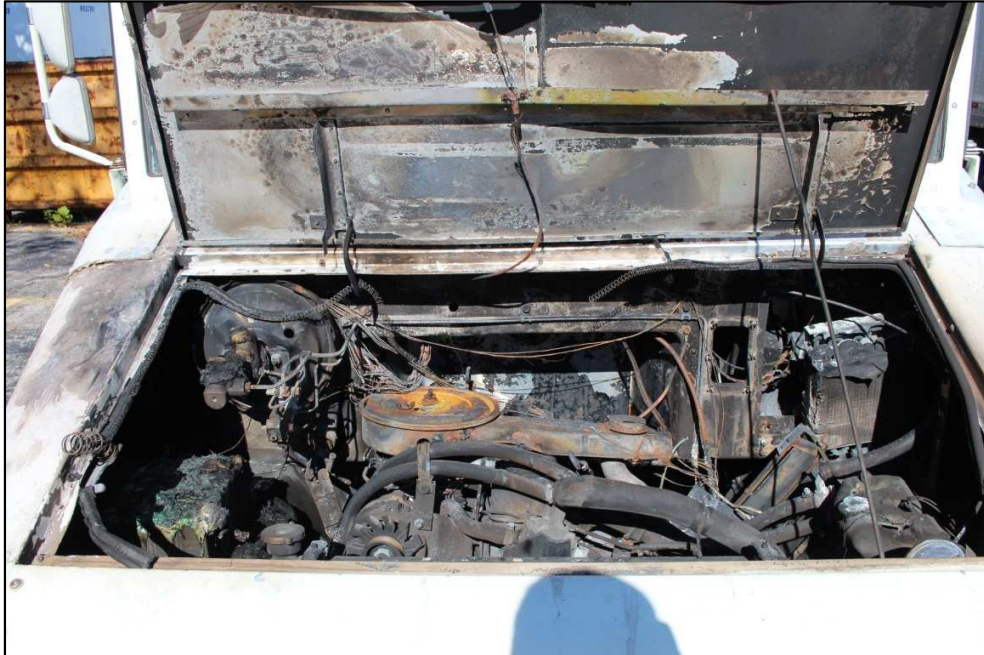
Photograph 3

Engine compartment. Notice more severe damage closest to fire wall.

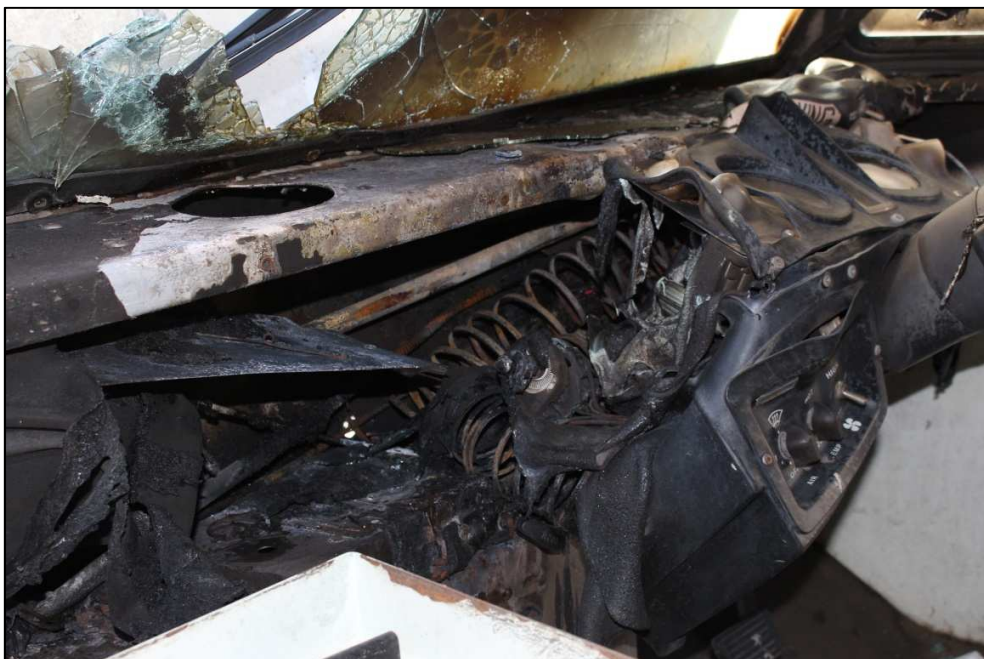
Photograph 4

View of dashboard.

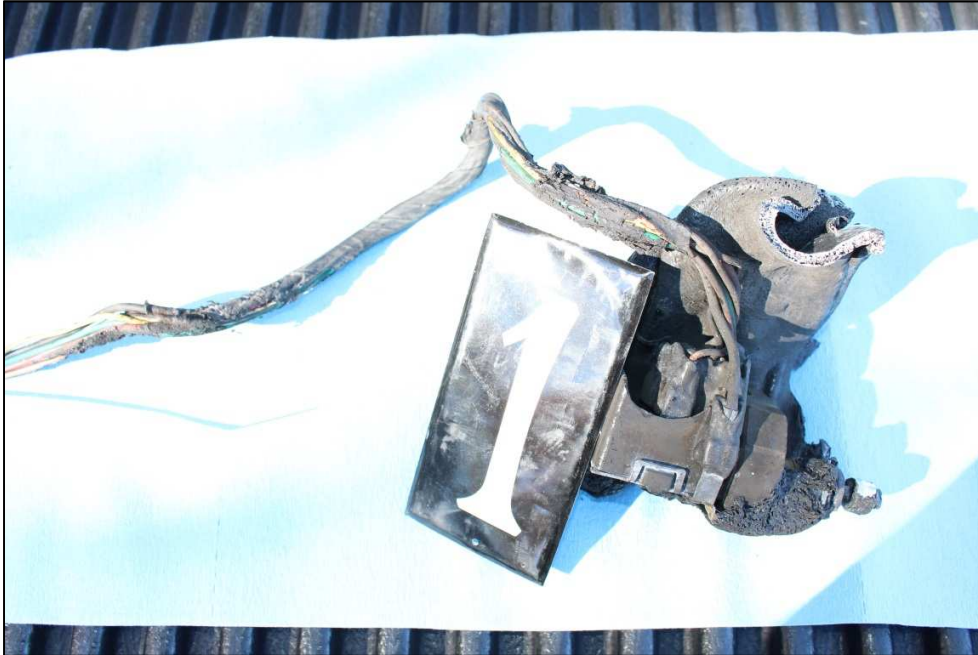
Photograph 7

Evidence collected #1- Headlamp switch assembly and associated wiring.

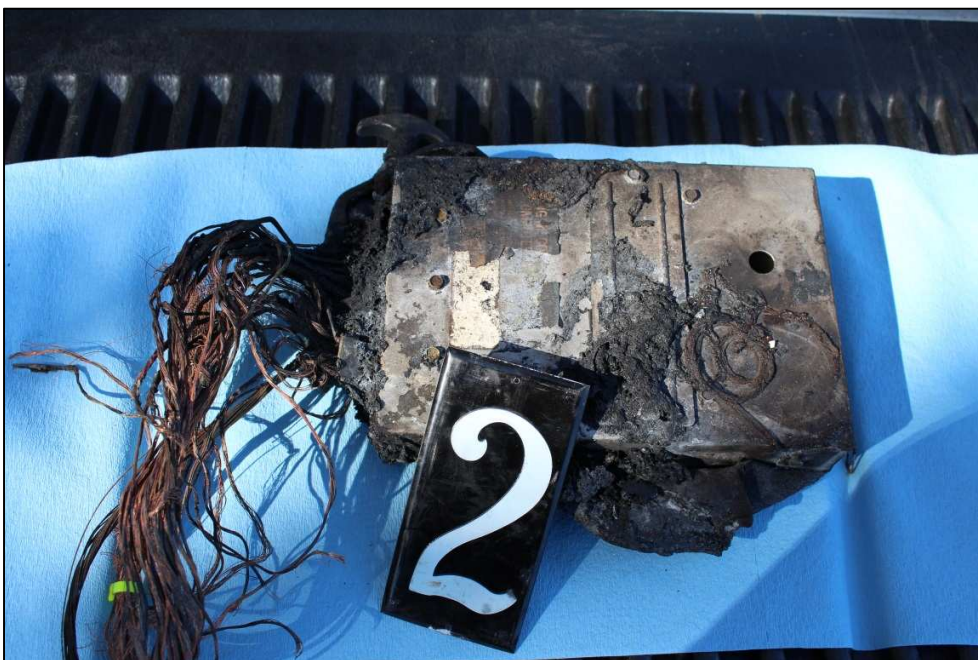
Photograph 8

Evidence collected #2- Vehicle computer and associated wiring.

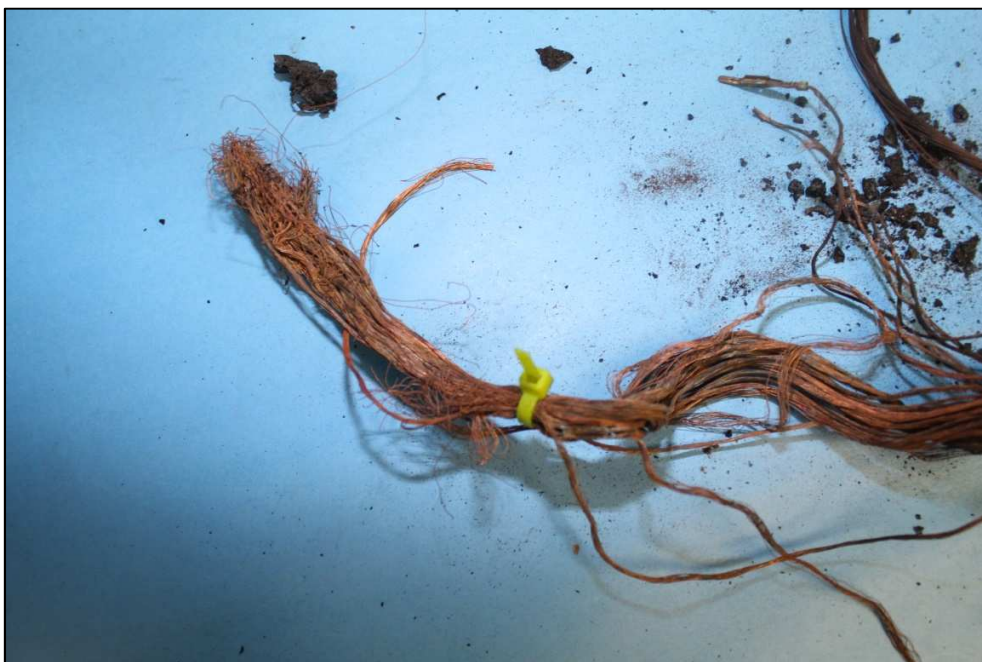
Photograph 10

Frayed and severed electrical wiring from the point of fire origin.

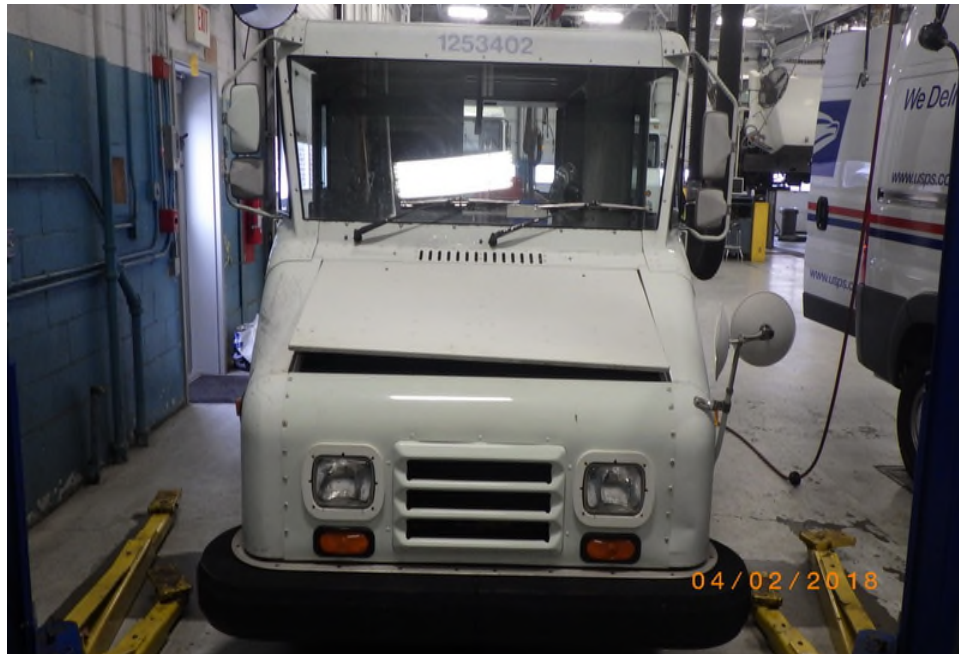
Photograph 1

A view of the exterior front of the vehicle.

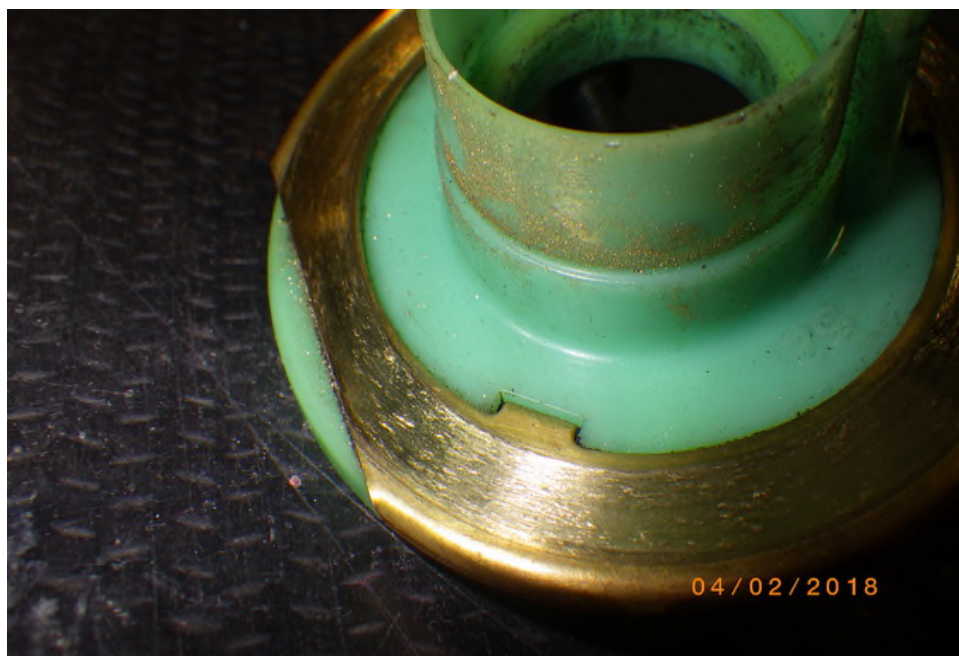
Photograph 4

A view of the horn ring.

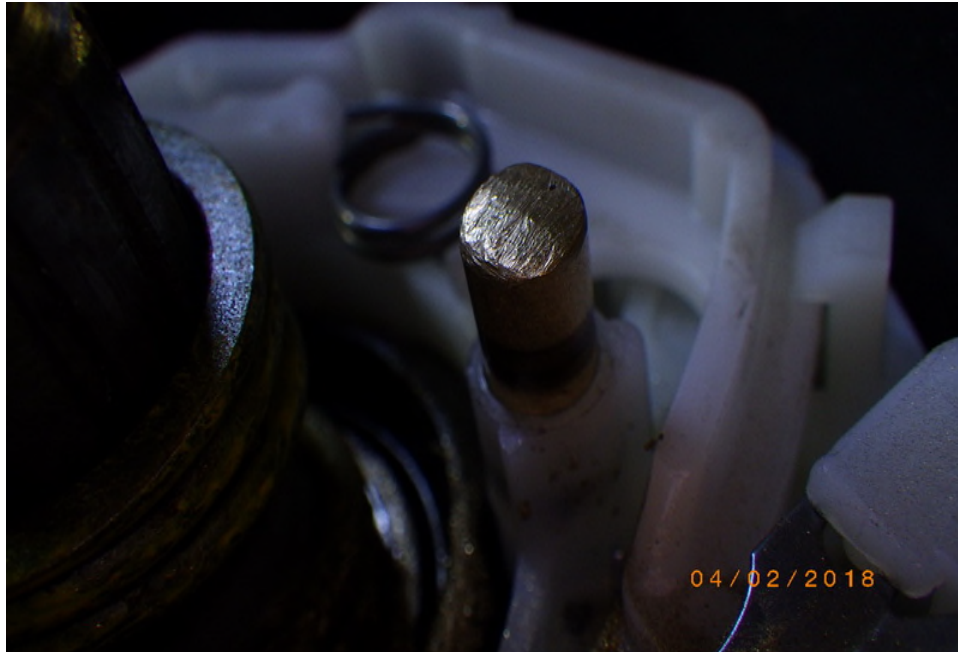
Photograph 5

A view of the horn button.

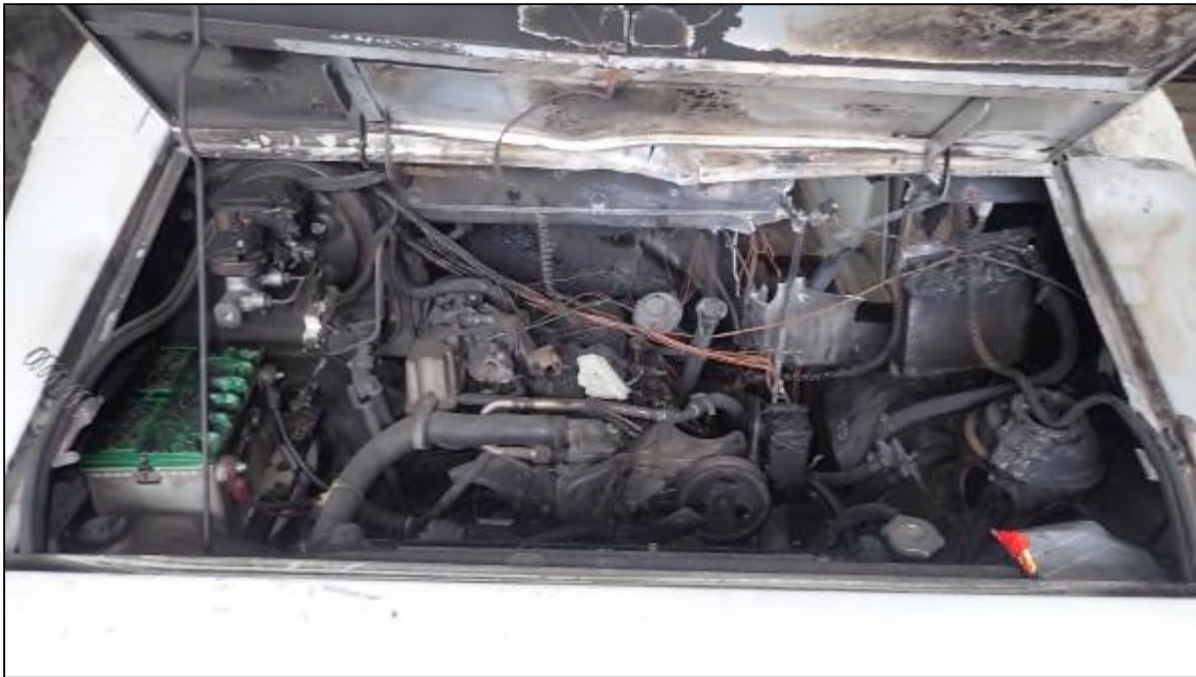
Photograph 3

The engine compartment was inspected. The vehicle was equipped with a 2.2L engine. The vehicle was also equipped with a fuel injected throttle body and electronic ignition. Some thermal and fire damage was observed in the engine compartment. Most of the combustible materials in the engine compartment were observed mostly intact. The greatest degree of fire damage was observed on top of the engine and in the area of the bulkhead along the left side. Most of the air filter housing that was located along the top of the engine had been consumed during the fire event.

View of the engine compartment.

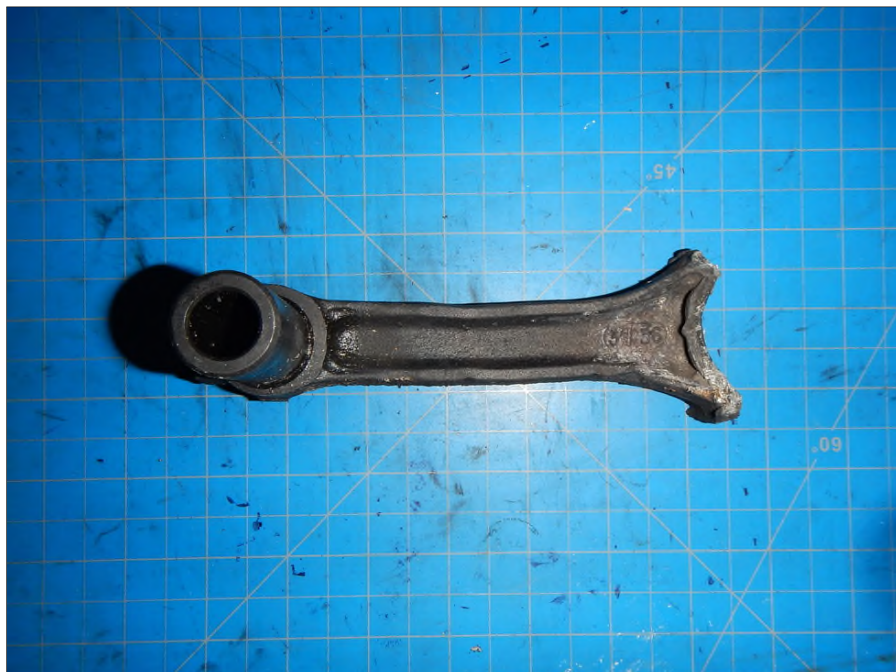
Photograph 6

Overview of the fractured connecting rod.

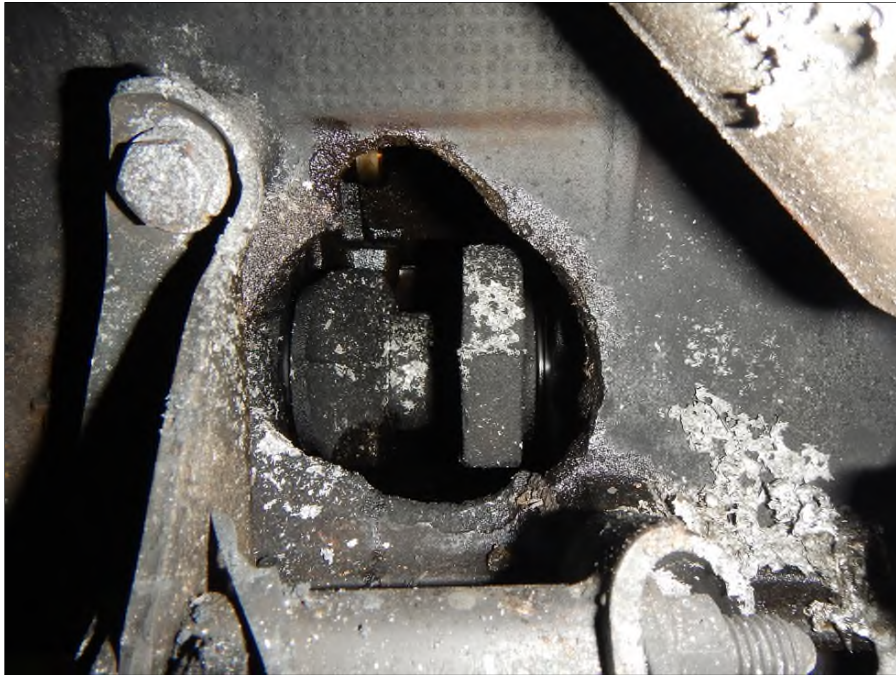
Photograph 7

Overview of the pierced engine block.
